# SACRAMENTO PLANT

INFORMAL PROGRESS LETTER NO. 36

30 SEPTEMBER 1965  
NERVA PROGRAM CONTRACT SNP-1

## ROCKET ENGINE OPERATIONS - NUCLEAR

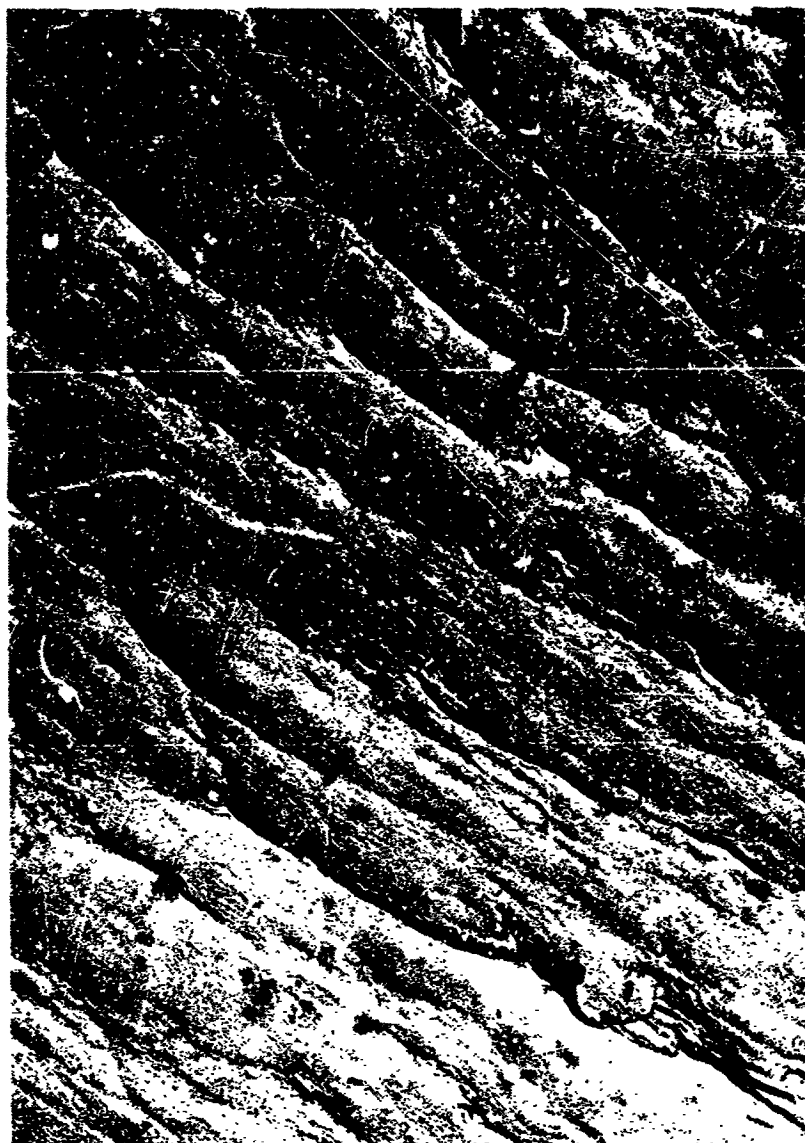
Figure 7

Characteristic fatigue striations are  
spaced at approximately 36 microinches  
between major peaks.

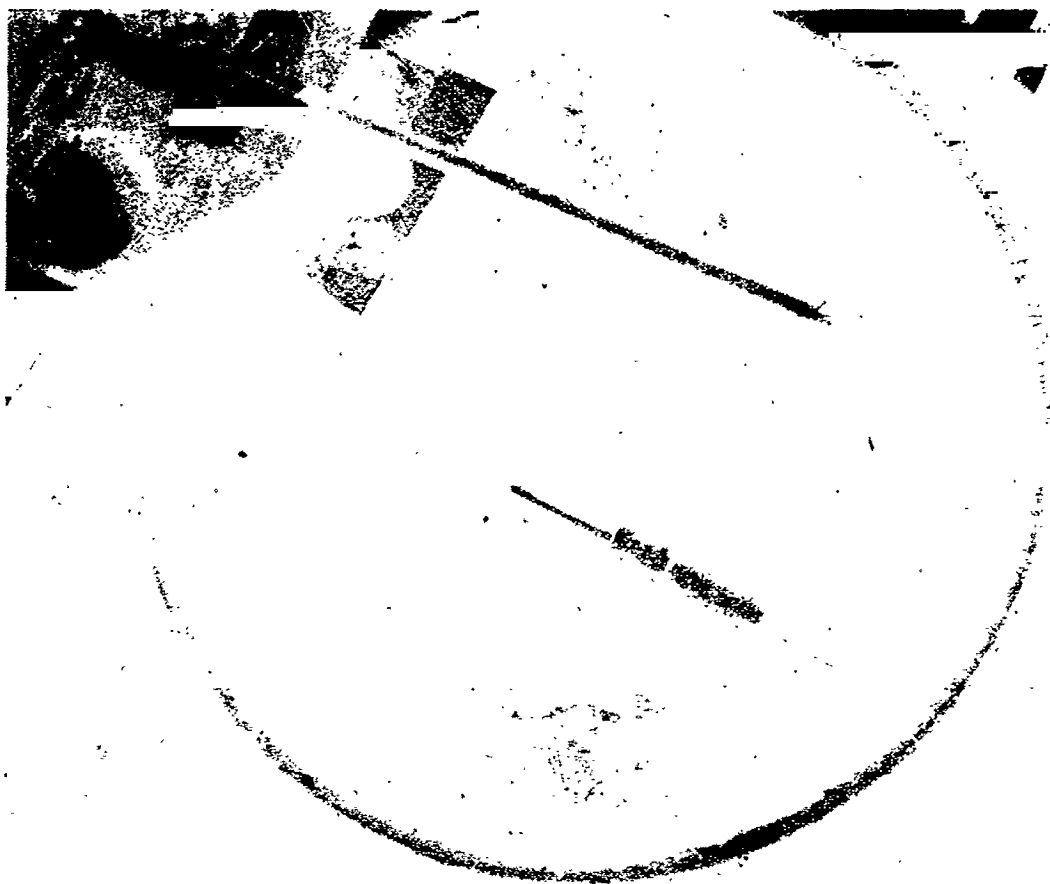
Figure 22

NRX/EST Pressure Vessel Closure  
Diluent/Closure Joint Test Assembly

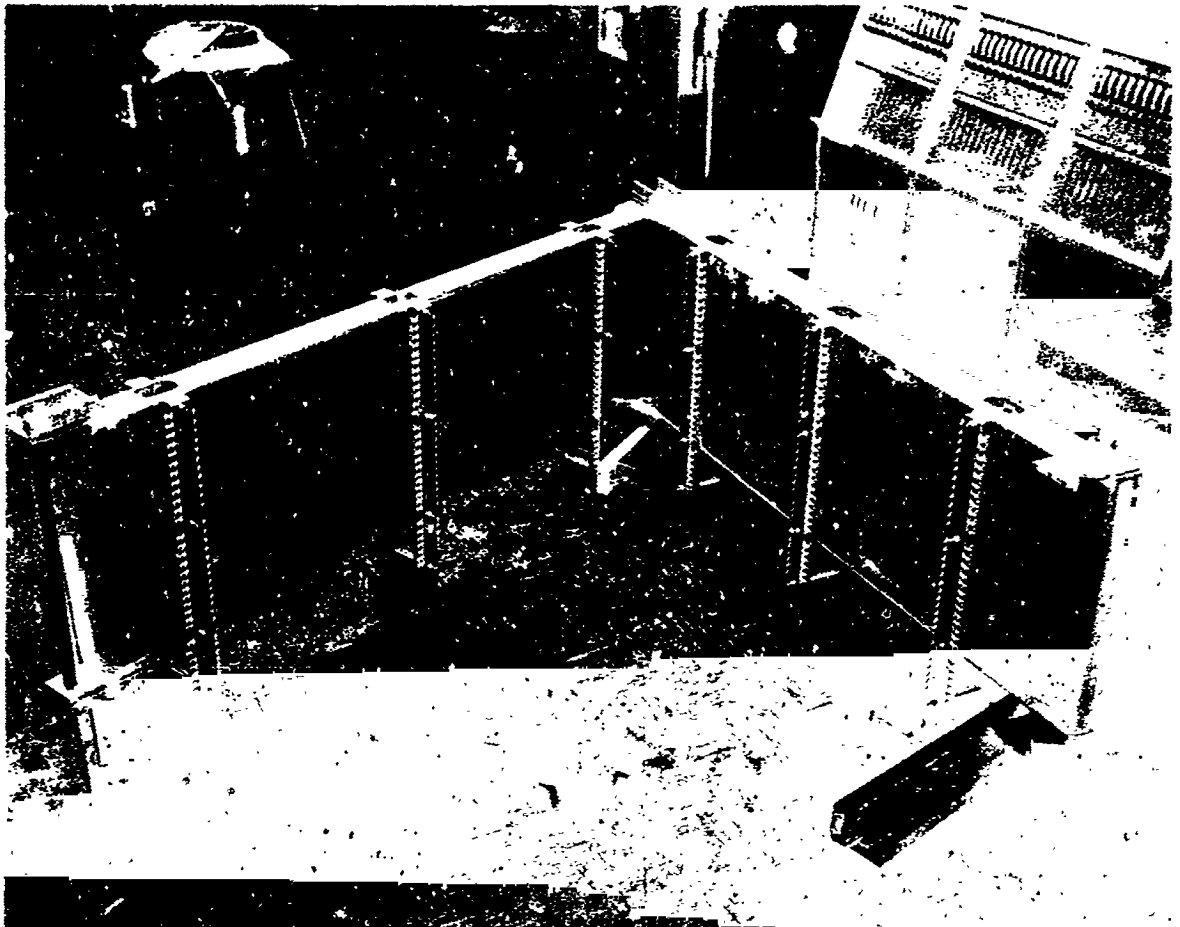
Figure 49  
Instrumentation Boom
